Maryland Inventory of Historic Properties Historic Bridge Inventory Maryland State Highway Administration Maryland Historical Trust

MHT Number CARR-1475

Name and SHA No.	Baumgardner Road over Piney Creek/CL202
<u>Location:</u> Street/Road Name and 1	Number: Baumgardner Road
City/Town: Bridgeport	Vicinity x
County: <u>Carroll</u>	
Ownership:State_x_Co	ounty_Municipal_Other
This bridge projects over	r:RoadRailway_x_WaterLand
Is the bridge located wit	hin a designated district: yes x no
NR listed distri locally designat Name of District_	
Bridge Type:	
Timber Bridge Beam Bridge Timber-and-Co	_Truss-CoveredTrestle
_Stone Arch	
Metal Truss	
Movable Bridge Swing Vertical Lift	Bascule Single LeafBascule Multiple Leaf _RetractilePontoon
	Rolled Girder Concrete Encased _Plate Girder Concrete Encased

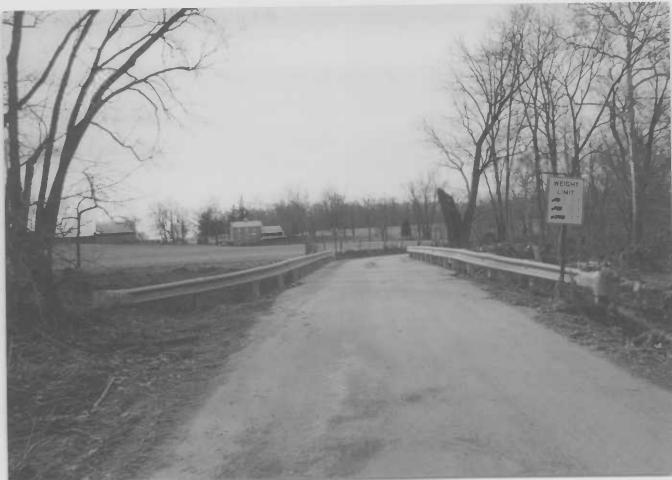
Number 4 of 35

Inventory # CMRR-14-75
CL202
Name Baumgardner Road over Piney Cre
County/State <u>Carrol/Co. Md.</u> Name of Photographer <u>D. Dieh/</u>
Name of Photographer D. Brent
Date <u>2-3-95</u>
Location of Negative SHA
Description North Approach looking South

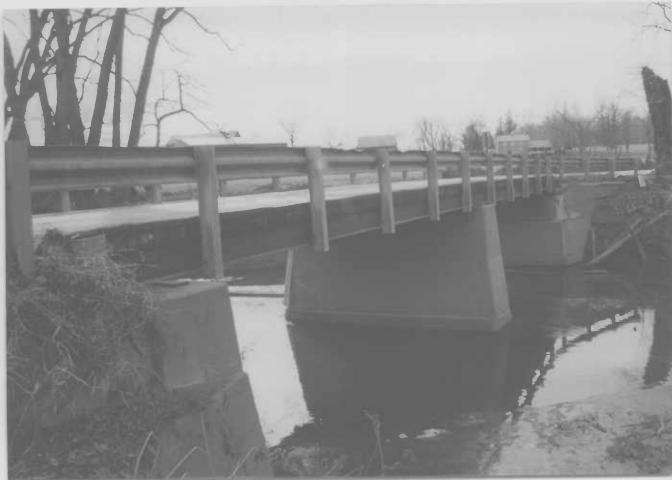
Number **8** of **3** 3

Name CL202 Baumgardner Road over Piney Cr County/State <u>Carroll Co. Md.</u>
County/State <u>Carroll</u> Co. Md.
Name of Photographer \(\) \(\) \(\) \(\) \(\)
Name of Photographer
Location of Negative SHA
Description West Elwation looking South East

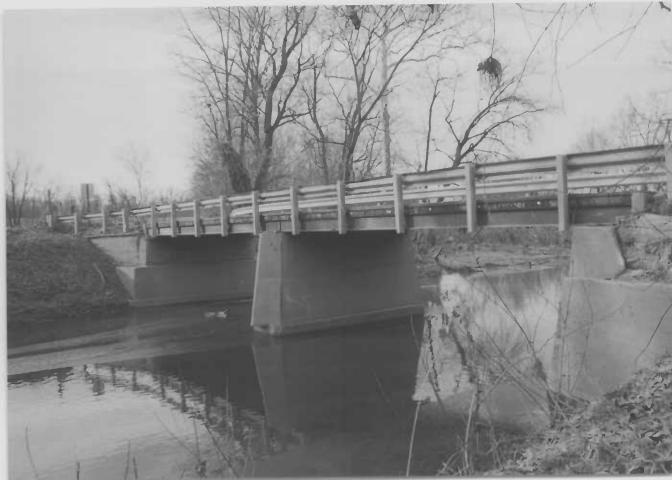
Number & of 33

Name <u>Cl 202 Boumgald ner</u> Rd. over <u>Piney Creek</u> County/State <u>Carroll Co. Md.</u> Name of Photographer <u>D. Die 4/</u> Date <u>Z/95</u>
Location of Negative SHA
Description East Elevation looking West

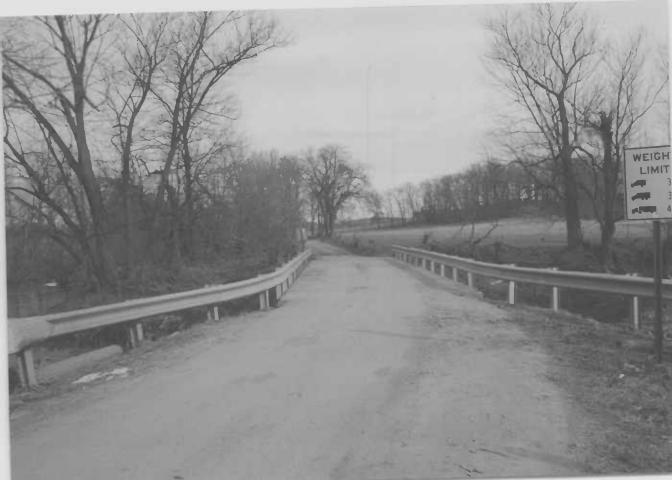
Name <u>Cl202 Baumgardner</u> <u>Fd. over Piney Cr.</u> County/State <u>Carrol/ Co. Md.</u> Name of Photographer <u>D. Dieh/</u> Date <u>2/95</u>	-	
Location of Negative 5HA		
Description South Approach looking North		
Number 7 of 33	2	*OF
